ANGLIA Range

HEATER PLENUM CHAMBER DRAIN TUBES

No 33

PASSENGER CAR SERVICE LETTER 1964 series

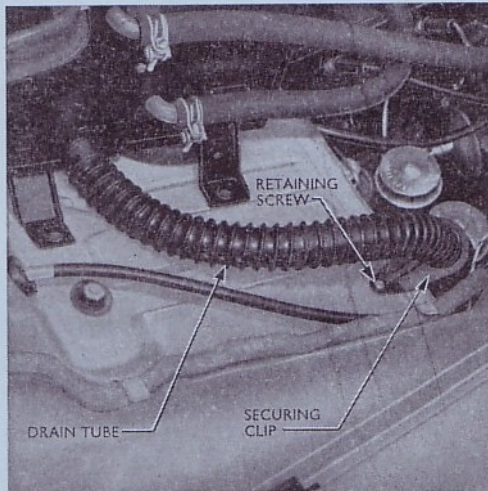
The metal plenum drain tubes and rubber elbow connections have been replaced by plastic drain tubes. The metal tubes will no longer be available in service once present stocks are exhausted.

If, for any reason, it is necessary to replace the metal tubes with the plastic ones, the holes for securing the clips to the windshield opening panel must be resited. The position of these holes is not critical but it is advisable to temporarily fit the pipe in position, refer to the accompanying illustration, and mark where the holes should be, using the clips as templates. The holes can be drilled (0.125 in. dia.), and the tubes can then be fitted and secured in position with a self-tapping screw through each clip.
